## Docket No. 217 - Development and Management Plan Inspection

Northeast Utilities Service Company Certificate of Environmental Compatibility and Public Need for the construction of a 345-kV electric transmission line and reconstruction of an existing 115-kV electric transmission line between Connecticut Light and Power Company's Plumtree Substation in Bethel, through the towns of Redding, Weston, and Wilton, and to the Norwalk Substation in Norwalk, Connecticut.

Date: November 2, 2005

**Location:** Overhead Line (Composite 345kV and 115kV Gallows Hill to Archers Lane)

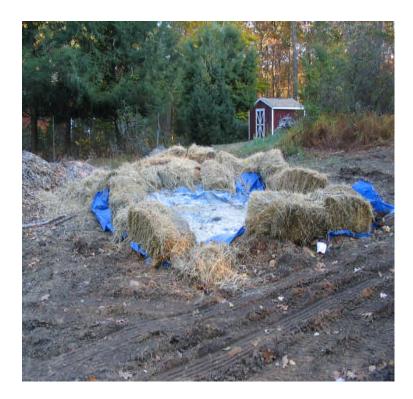
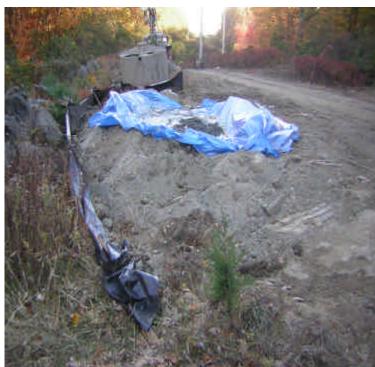
Overhead ROW: Both photos show washout areas for either concrete or dewatering of excavations. The photo on the left is for work on the Gallows Hill Rd. side of the ROW while the photo on the right is closer to Archers Lane. 11/2/05

- Two separate tarp/basins were noted on the ROW which were used either for concrete washouts or dewatering the foundations. 11/2/05	- Continue to use these areas. The material was contained at this time and nothing was noted on the ground. 11/2/05
	-Clearing occurred at the transition station/ROW edge at the recently approved access road location. Conditions had been muddy and erosion controls may need to be extended here if this is still the case. 11/2/05	-Determine if there is a need to install more erosion control in this location. 11/2/05
Inland Wetland and Watercourse encroachment and mitigation	-The D&M plan approved stone on geotextile fabric at the first wetland crossing is still working very well but the silt fence needs to be toed back in. 11/2/05	- None at this time, the crossings have been constructed. As the access is considered temporary, the stone will be removed when final work ends so the

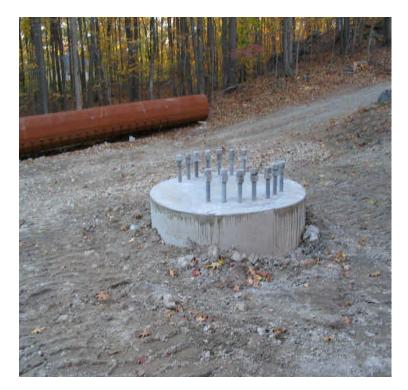
Photo on the left shows a foundation poured at the second structure in from Gallows Hill. Photo on the right shows the stockpile remaining at this location with wetlands beyond. 11/2/05

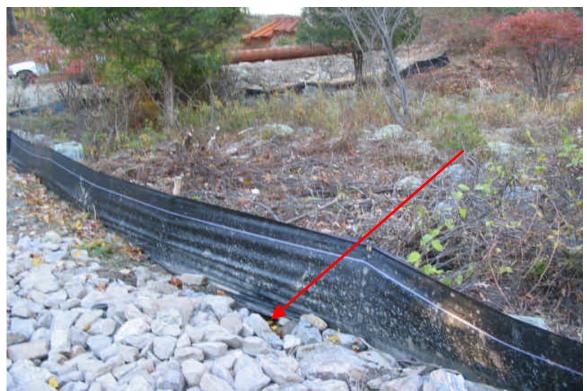
View of the flooded low spot/wetland crossing along the ROW. These crossings are well installed but the silt fence has started to pull out of the rocks in some spots and should be maintained. 11/2/05

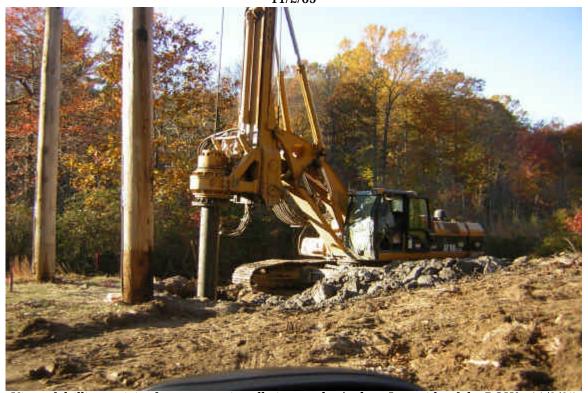
View of drilling activity for structure installation on the Archers Lane side of the ROW. 11/2/05

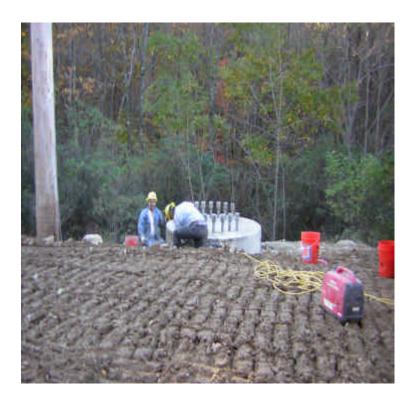
Photo on the left shows work on another structure foundation. Photo on the right shows where sediment has partially overwhelmed the silt fence but wetlands are not in the vicinity. 11/2/05

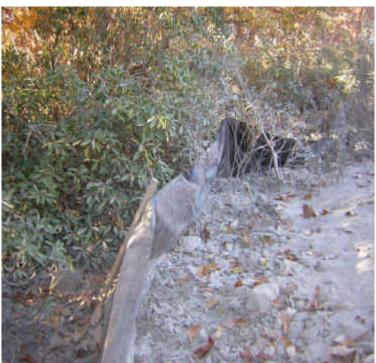
- Silt fence was in place around several stockpiles on the ROW. The one at the second structure near the wetlands is well enclosed. The others are in upland locations. One of the upland areas of silt fence was partially overwhelmed by sediment. 11/2/05	- Continue to maintain controls while the piles are present. 11/2/05

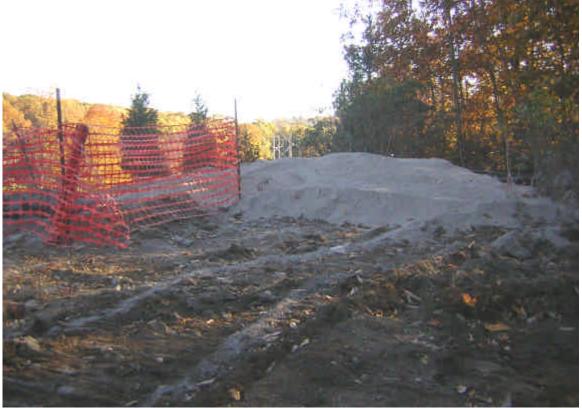
View of another structure excavation and the resulting sediment. Again, this area is considered upland with no adjacent resource areas. 11/2/05
